Loughton Town Council Tree Survey Report

Essex County Council

7 Roding Valley Nature Reserve

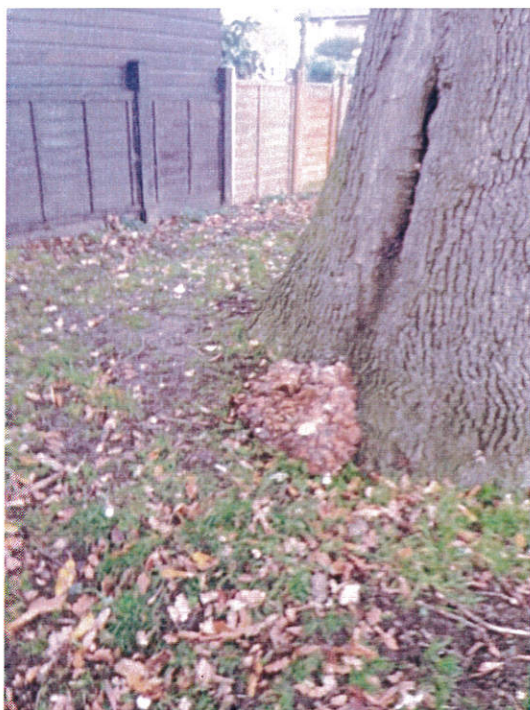
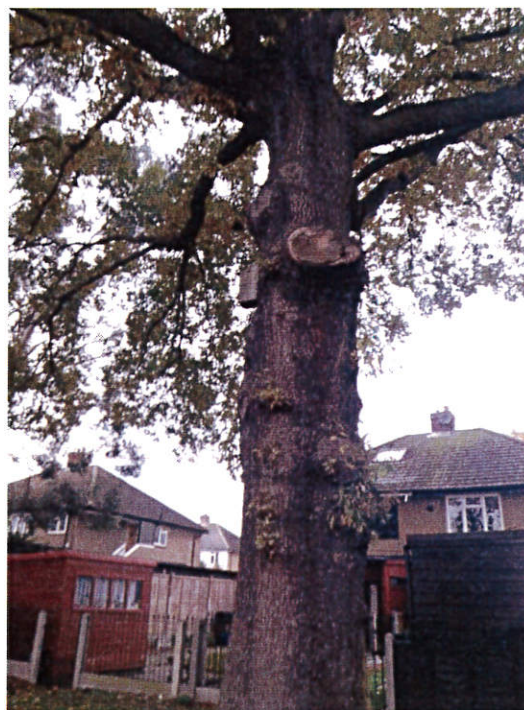
Tree number 404

Tree ref.	Tag No.	Species	Age	Height (m)	Crown Spread (m)	Stem DBH (cm)	Condition	Recommendations	Works Priority	Inspection Frequency
404	0028	Oak (<i>Quercus Spp.</i>)	M	27	20	104	Fair Condition, Fruiting body located at the base of the tree facing west. Suspected <i>Girfolia frondosa</i> .	Monitor tree condition annually.	0	5
469	0090	Oak (<i>Quercus spp.</i>)	OM	19	16	90	Fair, minor deadwood throughout the crown, die back present throughout the crown of the tree- multiple cavities from old pruning wounds, evidence of historic storm damage throughout the crown where limbs have previously failed.	Monitor tree condition annually.	0	5

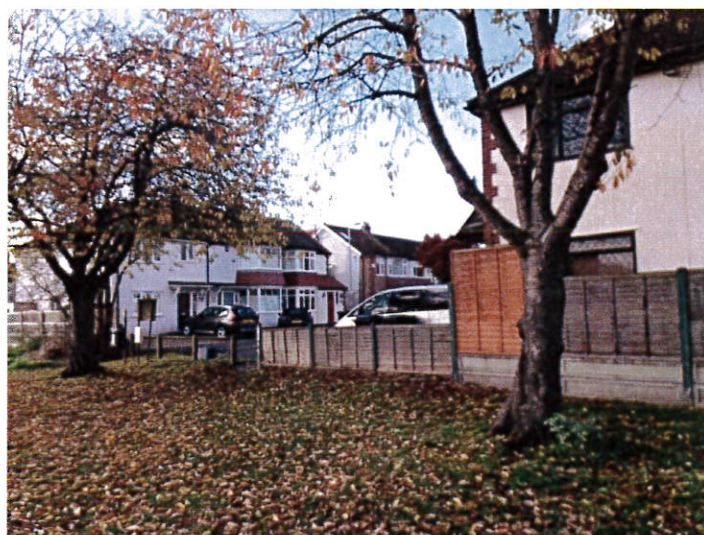
Tree number 486

486	0107	Cherry (<i>Prunus</i> <i>Spp.</i>)	M	14	10	55	Fair, multi-stemmed from ground level. Cavity present at the base, facing south. Minor Decay present within the wound good reaction present around the wound.	Monitor tree condition annually.	0	5
494	0113	Mixed broadleaf	M	16	10	45	Saprotrophic fungi present at the base, facing north. Mixed broadleaf group, all trees appear to be affected by bacterial	Monitor trees condition annually.	0	5
495	0114	Mixed broadleaf	M	12	10	40	canker. Deadwood has been removed. Mixed broadleaf group. Good condition, Some evidence of some of the trees being infected with bacterial canker of cherry.	1 x Dying Cherry tree located next to dog bin. Remove Dying tree.	3	5

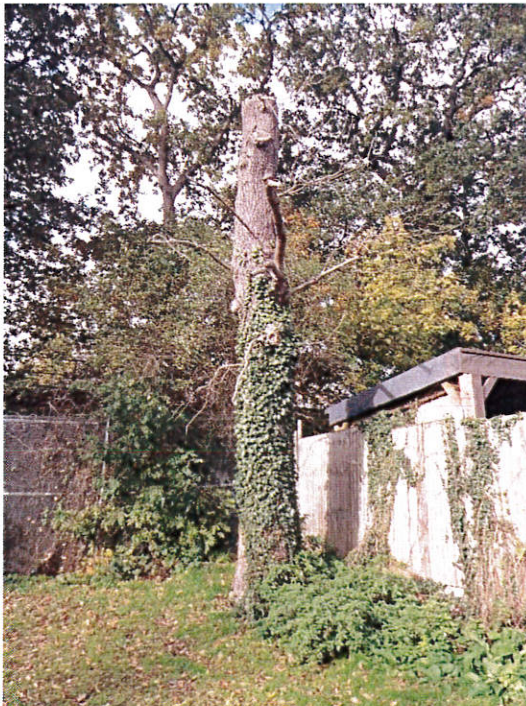
Tree Ref
102

Tree ref.	Tag No.	Species	Age	Height (m)	Crown Spread (m)	Stem DBH (cm)	Condition	Recommendations	Works Priority	Inspection Frequency
102	001195	Oak (<i>Quercus</i> spp.)	M	6.5	1	15	Tree previously monolithed, large cavity present at the base of the tree. Sound test confirmed evidence of severe decay within trunk.	Fell to ground level.	3	0
